# Falcon-Midway 115 kV Line Uprate Project Report

12/1/2008

The function of this project is to uprate the 26.7 miles of Tri-State's 115 kV line between Midway and Falcon substations from 50° C to 75° C construction. The existing line was constructed in 1974 with 477 ACSR conductor at a spacing that only allows for operation at a maximum of 50° C. Consequently, portions of this line are only rated for a static thermal rating of 95 MVA, which is limited only by the conductor capacity at 50° C construction spacing. Raising, moving, or rebuilding the structures along this line to achieve a 75° C operational rating will raise the overall line rating to 140 MVA, and will provide for an additional 45 MVA of capacity for Tri-State to serve Mountain View Electric Association's (MVEA) customer load.

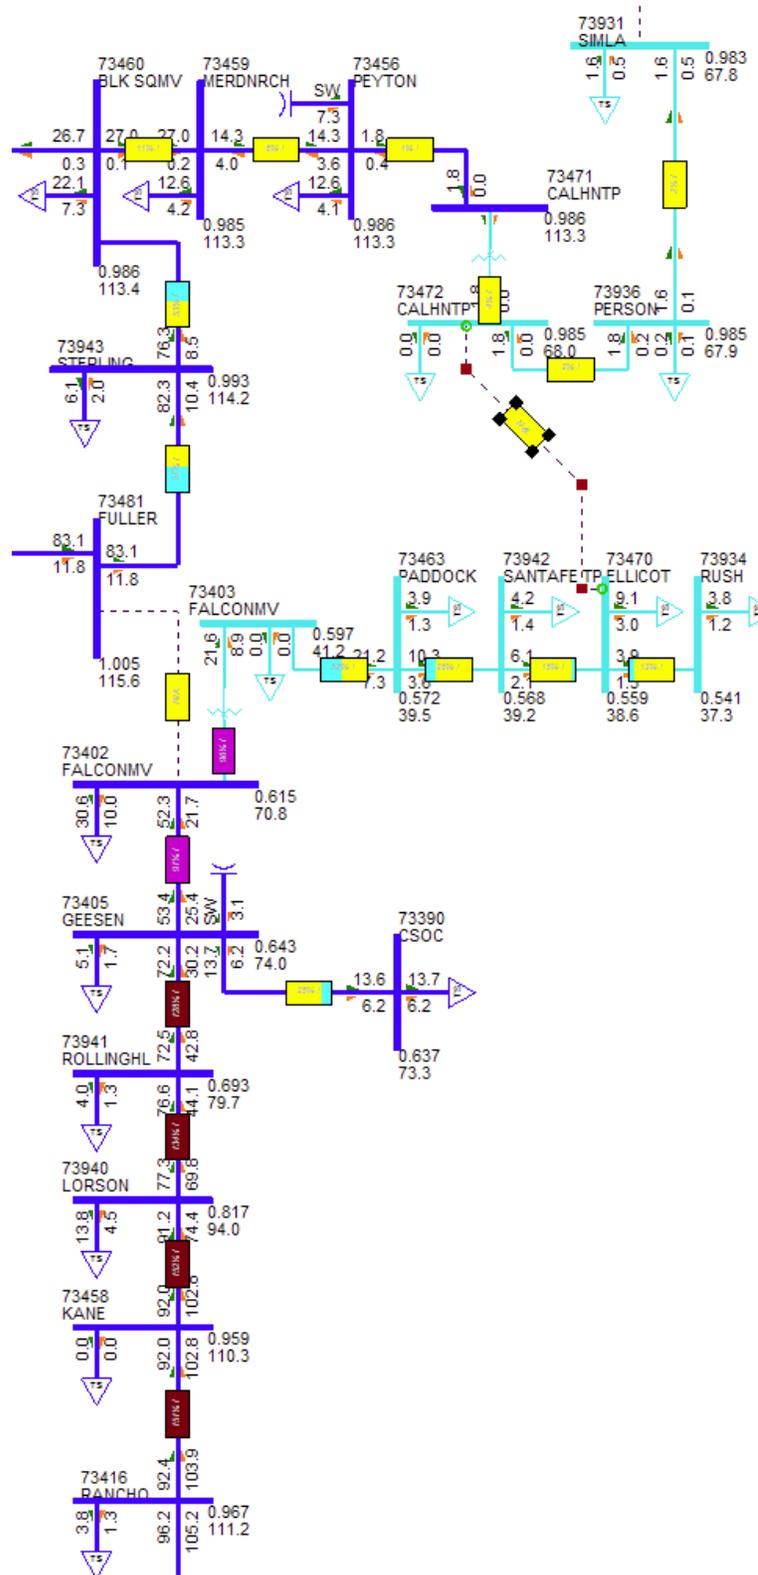
Figure 7 – 2018 HS Falcon-Fuller 115 kV Outage

At the time this study was performed, the critical contingencies for MVEA's regional transmission area were the loss of the Fuller 230-115 kV Transformer, and the loss of the Falcon-Fuller 115 kV line. These contingencies cause several worst-case overloads, shown in Table 10, and low-voltage violations. For the outage of the Falcon-Fuller 115 kV line, severely low voltages in the range of 0.80 pu at Lorson Ranch, and 0.50 pu at Rush 69 kV, were identified in the study.

It should be noted that the load at Falcon 115 kV is 20 MW higher than what was originally included in the 2018 HS WECC case. However, even when the 115 kV load at Falcon remained at the WECC value of 11 MW, the load growth attributed to the new delivery subdivisions of Lorson Ranch, Rolling Hills, and Santa Fe still resulted in voltage violations of 0.88 pu at the Rolling Hills 115 kV bus, and 0.79 pu at the Rush 69 kV bus.

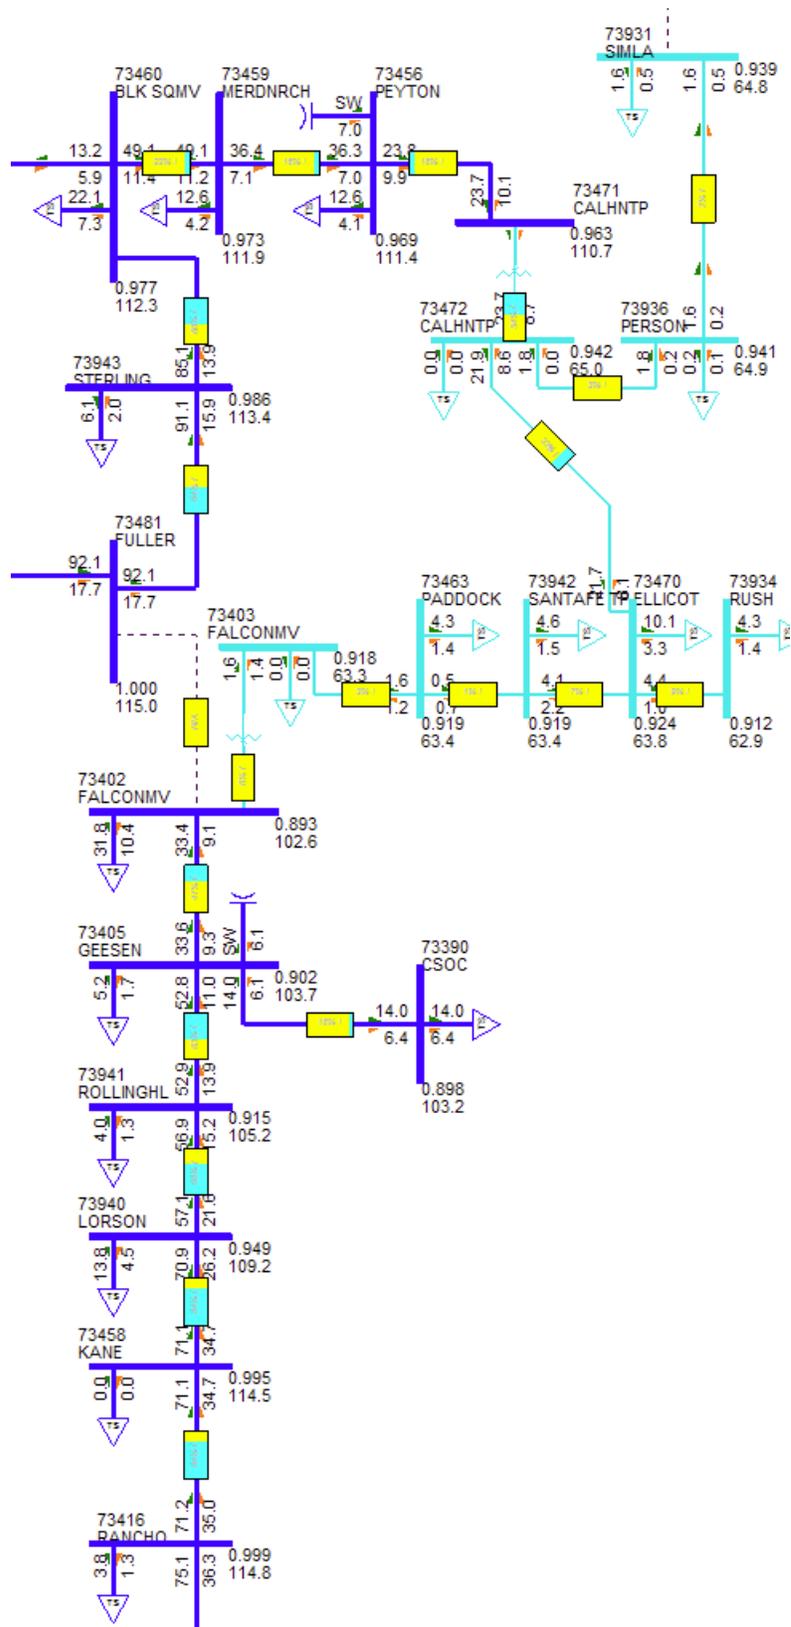
Figure 8 – 2018 HS Falcon-Fuller 115 kV Outage with Calhan-Ellicott 69 kV Inservice

The Calhan-Ellicott 69 kV line may be able to be operated as normally closed in the near term to provide additional voltage support to the 69 kV system east of Falcon. However, in the 2018 HS model, an overload of 132% of the Falcon 115-69 kV transformer's 42 MVA rating occurred during an outage of the Black Squirrel-Meridian Ranch 115 kV line.

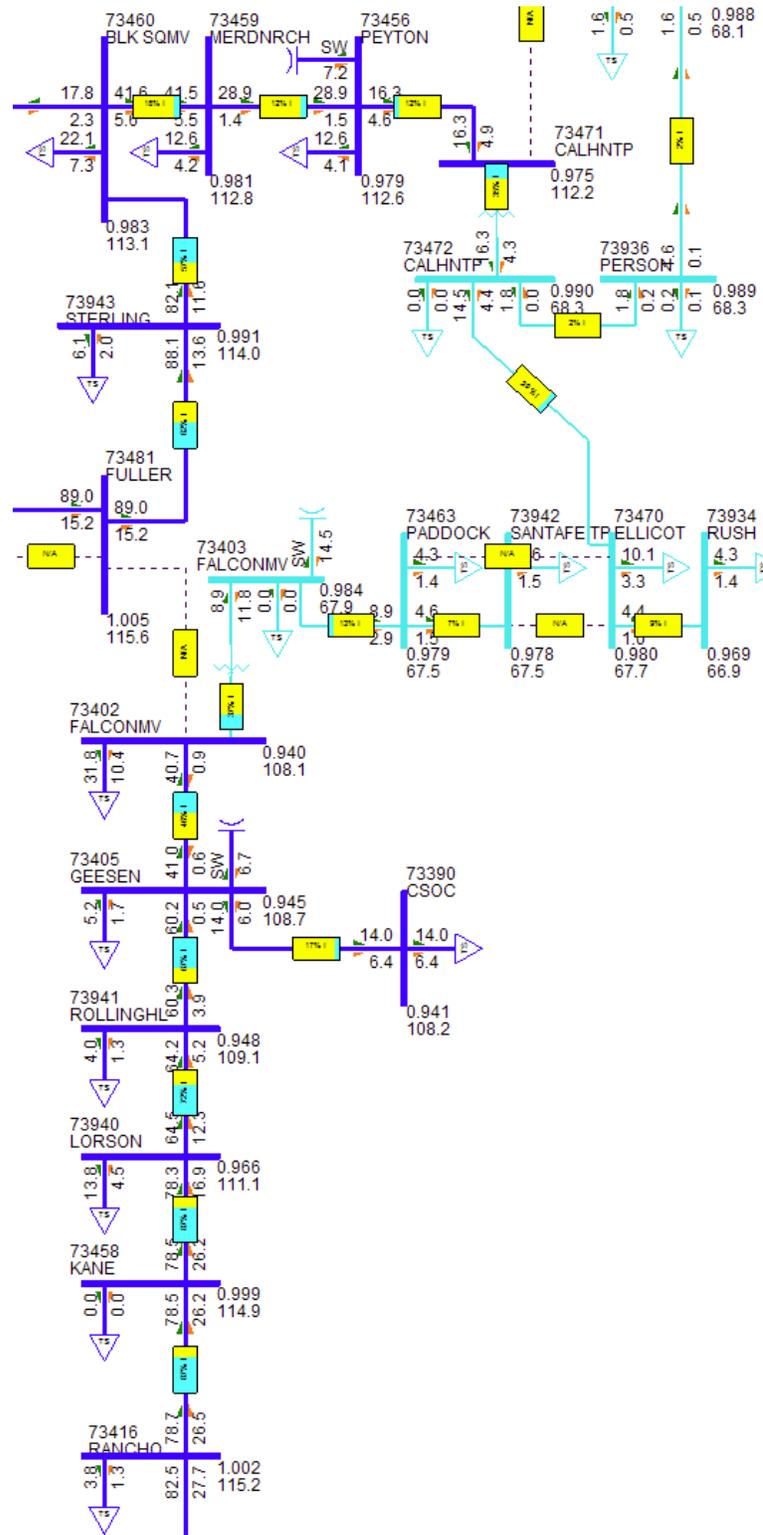
**Figure 9 – 2018 HS Falcon-Fuller 115 kV Outage with Ellicott and Rush Fed From Calhan, Calhan 115-69 kV transformer tapped at 112.125 kV, and 15 MVAR Capacitor Bank at Falcon**

Presently, the Calhan-Ellicott 69 kV line is operated normally open, energized at one end. The line is maintained by Mountain View and operational at all times. If it is determined that the line cannot be operated as normally closed, then significant reactive power resources must be applied to the 69 kV system. One option is to close the Calhan-Ellicott 69 kV line and open the Ellicott-Santa Fe 69 kV line in order to serve Ellicott and Rush from Calhan. Adequate voltage can be maintained during the Falcon-Fuller 115 kV outage by tapping the Calhan 115-69 kV transformer at 112.125 kV, and adding a 15 MVAR capacitor bank at Falcon 69 kV. Additionally, overloads on the 115 kV system from Geesen to Rancho are mitigated in this scenario, which is shown in Figure 9.

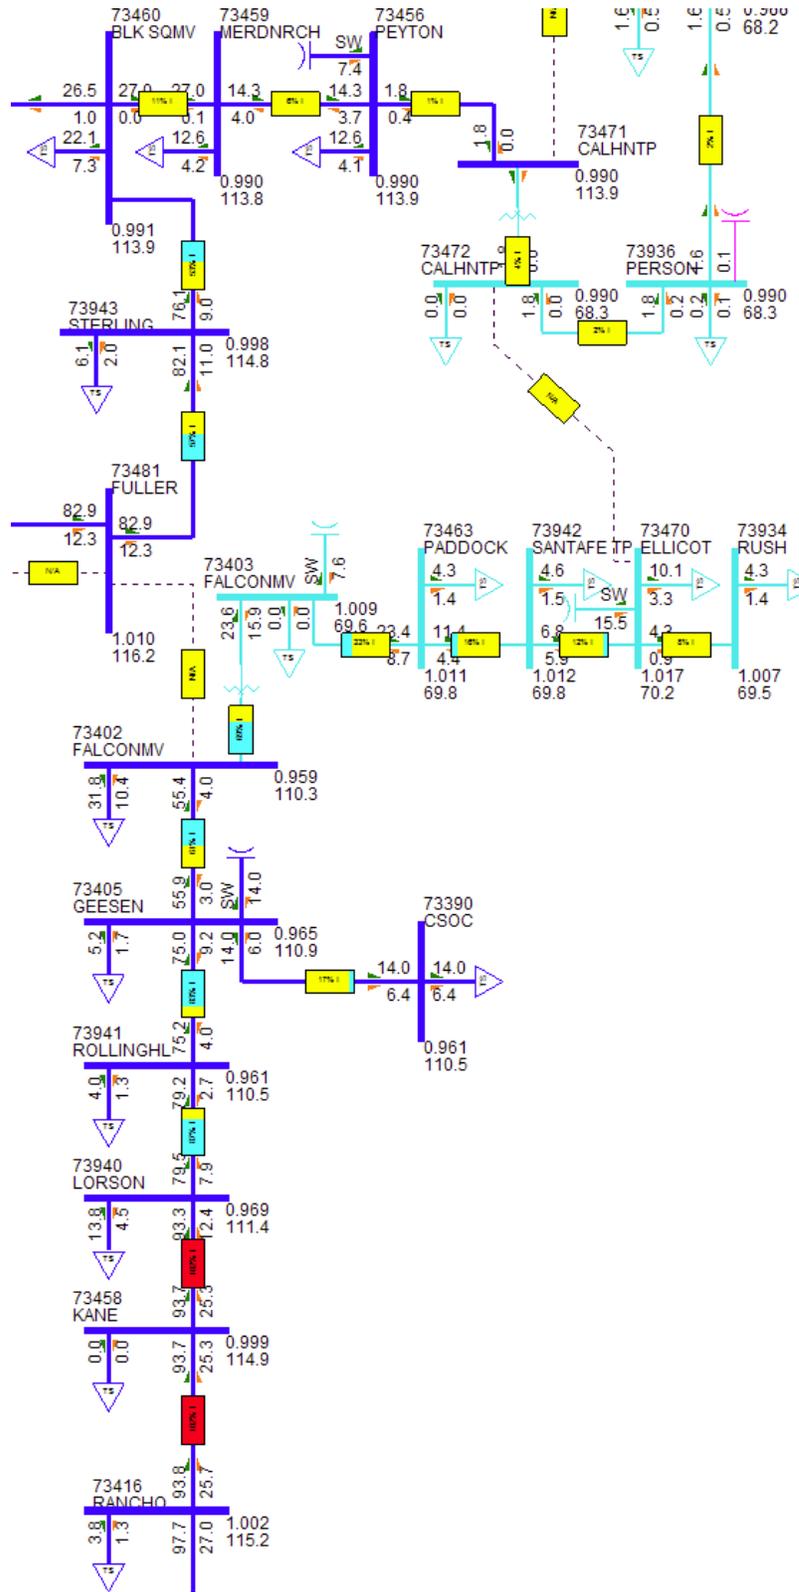
Figure 10 – 2018 HS Falcon-Fuller 115 kV Outage with Capacitor Banks at Geesen, Falcon, and Ellicott

A second option is to install capacitor banks at several locations. The installation of a 7.5 MVAR capacitor bank at Falcon 69 kV bus, a second 7.5 MVAR bank at Geesen for a total of 15 MVAR at Geesen, and a 15 MVAR bank at Ellicott would be required to support voltage greater than 0.95 pu at Rush during the Falcon-Fuller 115 kV outage. Figure 10 shows the voltage support supplied by these capacitor banks during the Falcon-Fuller 115 kV outage.
